**PRELIMINARY ASSESSMENT/
VISUAL SITE INSPECTION**

**GENERAL ELECTRIC COMPANY
ELECTRICAL DISTRIBUTION AND
CONTROL DIVISION
BLOOMINGTON, ILLINOIS
ILD 005 453 691**

FINAL REPORT

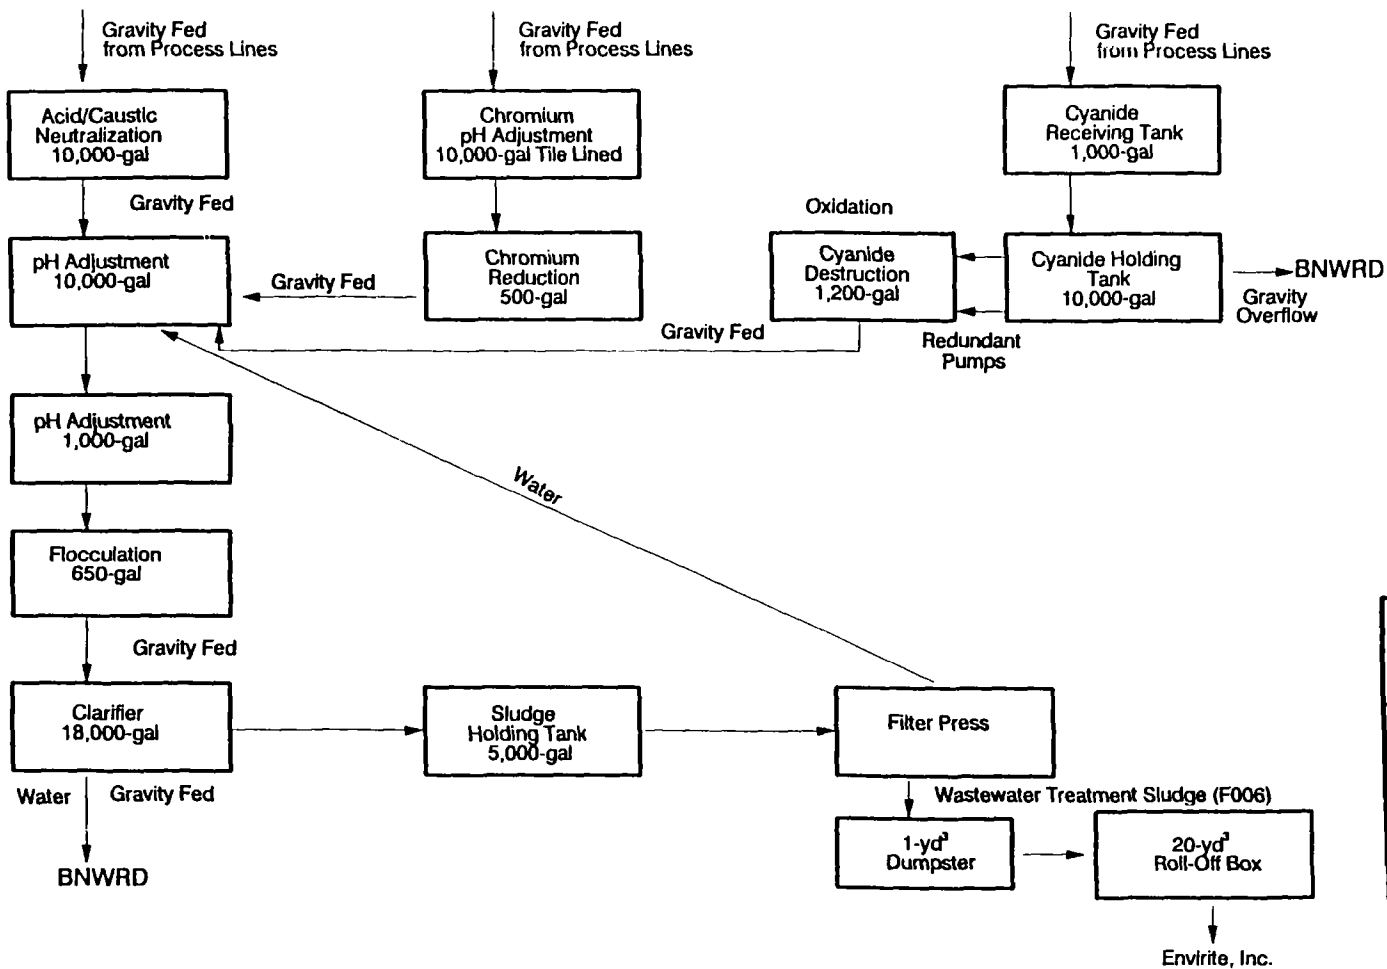
Figure 3
WASTEWATER TREATMENT UNIT
PROCESS FLOW DIAGRAM

The Wastewater Treatment Unit is located indoors, in a room on the east side of the facility. The unit treats wastewater from the plating and painting processes. Wastewaters from these processes are gravity fed by pipe to the unit. There are three waste streams: (1) acid waste

stream, (2) cyanide, and (3) chromium. A process flow diagram of the Wastewater Treatment Unit is shown in Figure 3. The acid waste stream first enters a 10,000-gallon concrete receiving tank, which is inground, and then flows by gravity to another 10,000-gallon concrete tank for pH adjustment, where the precipitation process starts. The wastewater is then pumped to a 1,000-gallon fiberglass tank for further pH adjustment, and the precipitation process is finished. The wastewater is then pumped to a 650-gallon fiberglass flocculation tank. A gravity-fed line moves the wastewater from the flocculation tank to an 18,000-gallon steel clarifier tank. Clarifier overflow is then gravity fed and discharged into the sanitary sewer. Two to three times a week, the sludge is pumped out of the clarifier tank to a 5,000-gallon fiberglass sludge holding tank. The sludge is then pumped into a filter press to remove excess wastewater. The excess wastewater is pumped back to the second 10,000-gallon concrete pH adjustment tank in the acid waste stream. The wastewater treatment sludge (F006) is transferred from 1-cubic-yard steel dumpsters into a 20-cubic-yard roll-off box and stored at SWMU 8. The cyanide stream first enters a 1,000-gallon fiberglass receiving tank and is then pumped to a 10,000-gallon fiberglass holding tank. Redundant pumps move the wastewater to a 1,200-gallon fiberglass tank for cyanide destruction. The second pump is used as a backup in case the first pump fails. If this should occur, an alarm will sound and the second pump will move the wastewater to the 1,200-gallon cyanide destruction tank. If both pumps were to fail and the 10,000-gallon holding tank overflowed, the wastewater would flow by gravity and discharge into the sanitary sewer. After the cyanide is destroyed, the wastewater is gravity fed to the second 10,000-gallon concrete pH adjustment tank in the acid waste stream. The chromium stream enters a 10,000-gallon concrete tank lined with acid resistant tile by

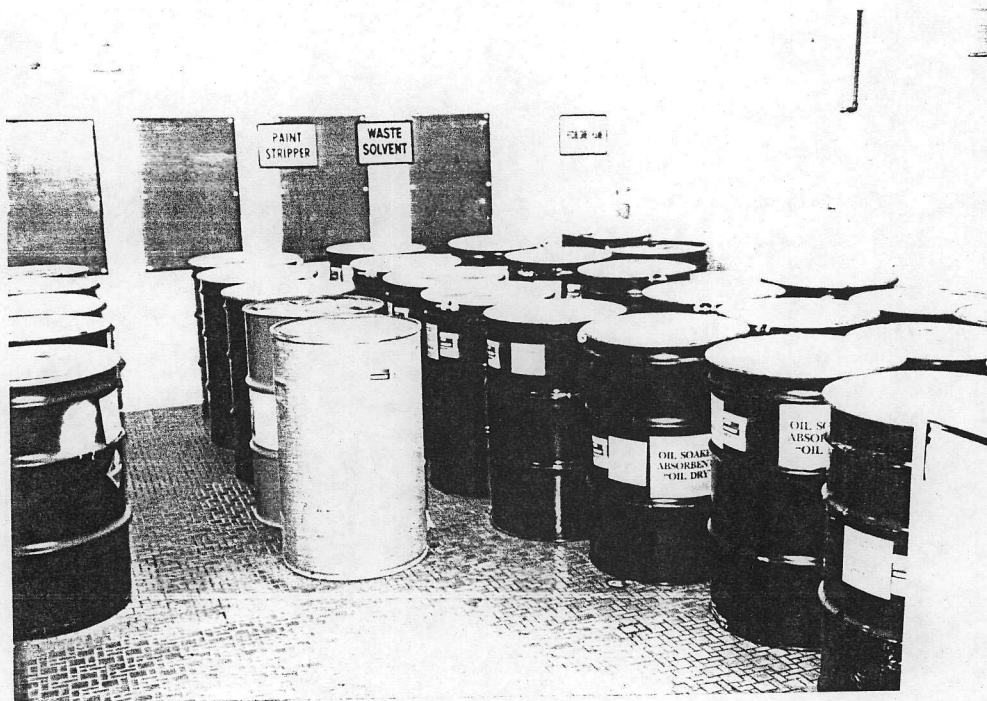
Photograph No. 1

The Hazardous Waste Storage Area is located indoors, in a room on the east side of the facility. The unit stores hazardous waste for less than 90 days. The unit measures 15 feet by 20 feet and is made of ceramic tile over a concrete floor. The floor slopes up toward the entrance (see Photograph No. 1). Floor drains are plugged in this room.

The unit contained 31 closed 55-gallon steel drums and one cardboard 55-gallon drum during the VSI. No cracks were visible in the floor. The cardboard container stored spent aerosol cans. The rest of the drums contained paint waste (F003/F005), paint sludge (D001), wastewater treatment sludge (F006), and spent TCA (F001/F002). No evidence of release was noted.

Description: Hazardous Waste Storage Area. Drums contain spent TCA (F001/F002), waste paint (F003/F005), spent aerosol cans (brown drum), and nonreturnable gloves and rag waste (F003/F005).

Recommendations: RAI recommends no further action at this time.

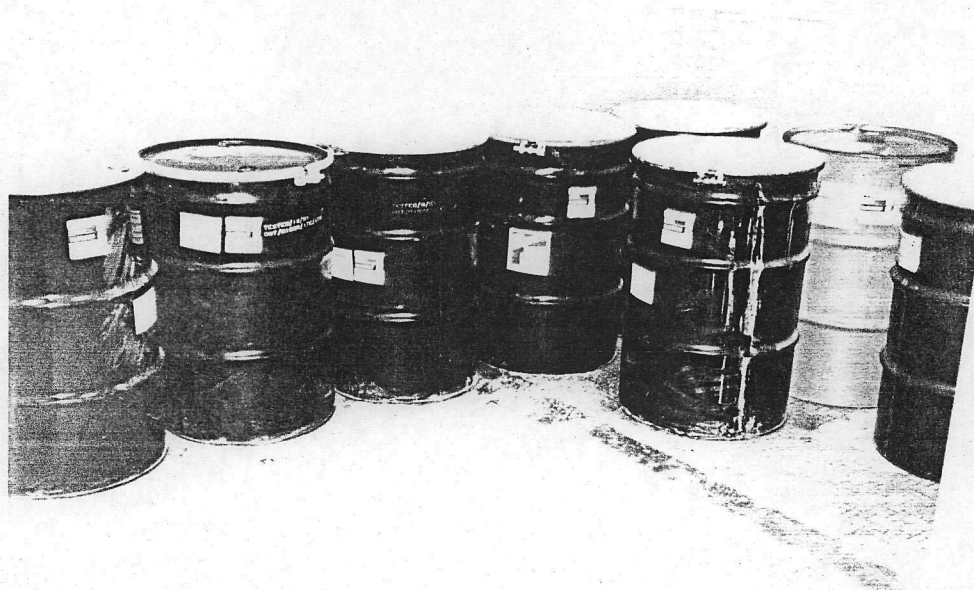
Photograph No. 2

The room where waste oil and coolant are stored contained 10 closed drums of nonhazardous waste oil and coolant during the VSI. No cracks were visible in the floor. No evidence of release was noted. In the area where special waste polyester paint is stored, one 55-gallon drum of polyester paint waste was observed during the VSI. No cracks were visible in the floor and no evidence of release was noted. The grinding sludge was stored in one 90-gallon container during the VSI. No cracks were visible in the floor and no evidence of release was noted.

Description: Nonhazardous Waste Storage Area. Drums contain nonhazardous waste oil and nonhazardous washer sludge.

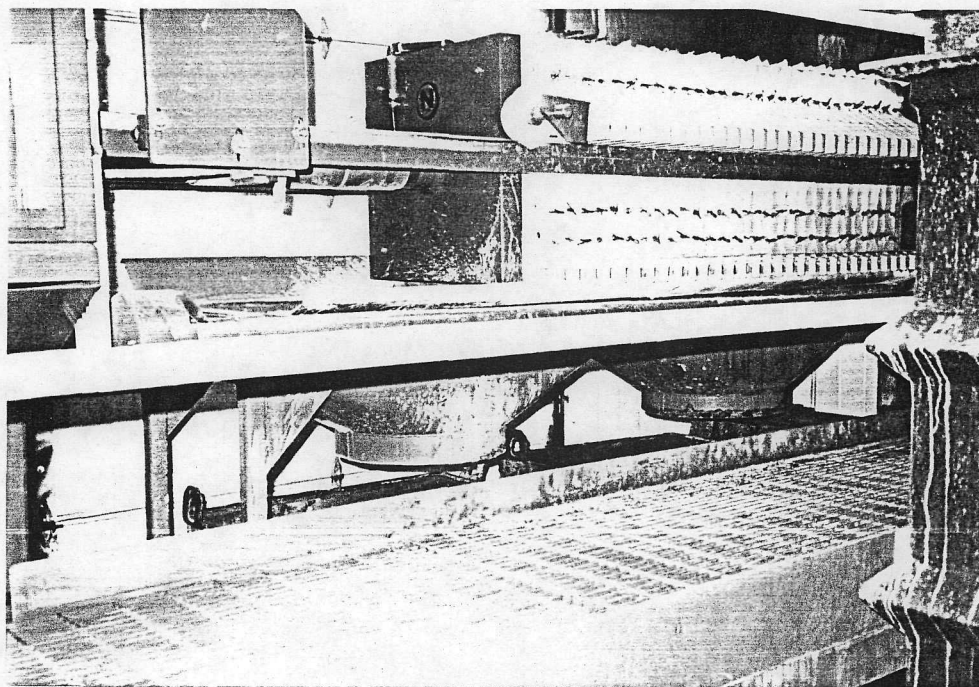
Photograph No. 4
 Orientation: East
 Description: Filter press for Wastewater Treatment Unit

Location: SWMU 3
 Date: 01/24/92

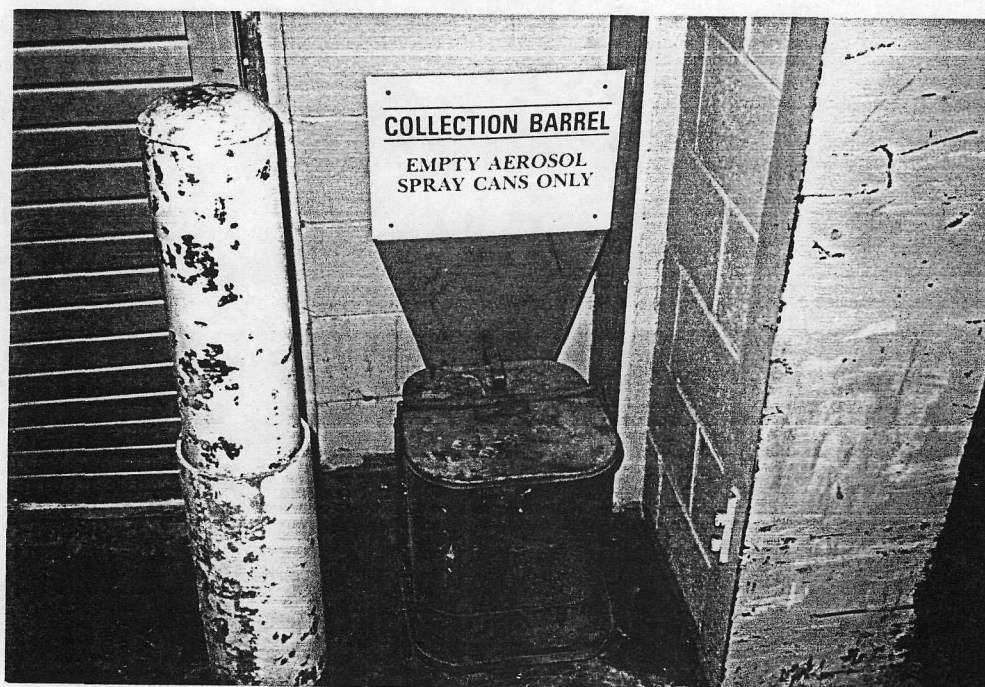
The Hazardous Waste Satellite Accumulation Areas are located by the truck dock and in the paint room. The area by the truck dock is a metal 20-gallon container which accumulates spent aerosol cans. The area in the paint room accumulates used rags and gloves in a 15-gallon metal container (see Photographs No. 5 and 6).

During the VSI, the unit contained one 20-gallon container that accumulated spent aerosol cans. In the paint room, the unit contained hazardous gloves and towels (F003/F005) accumulating in one 15-gallon container. No cracks were visible in the floor. No evidence of release was noted.

Photograph No. 5
 Orientation: East
 Description: Hazardous Waste Satellite Accumulation Area of empty aerosol spray cans

Location: SWMU 4
 Date: 01/24/92

Recommendations: RAI recommends no further action at this time.

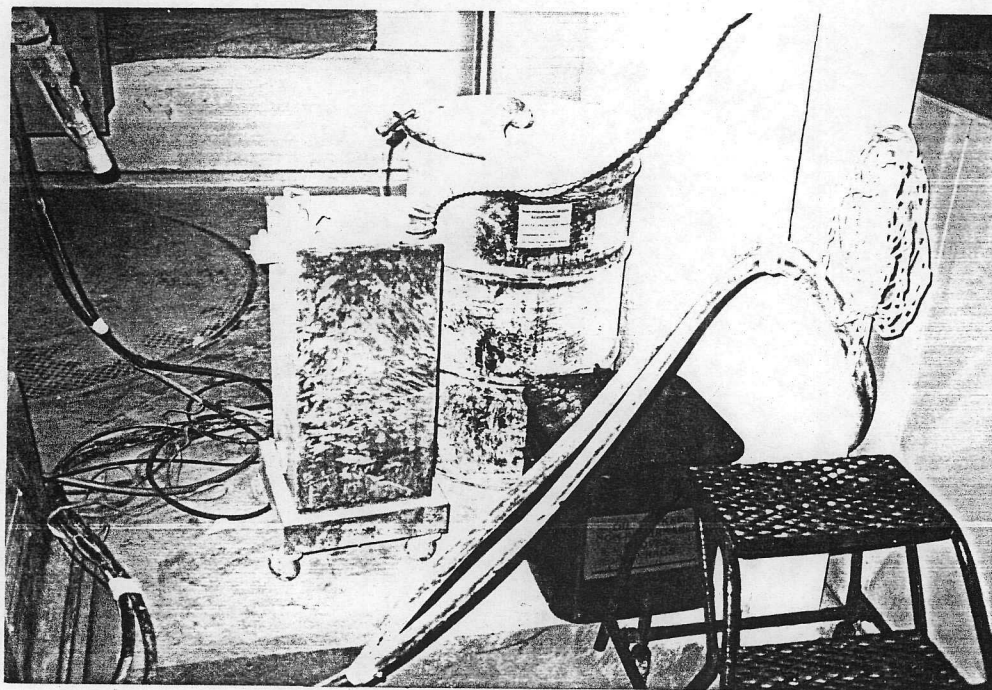
Photograph No. 6

Location: SWMUs 4 and 2

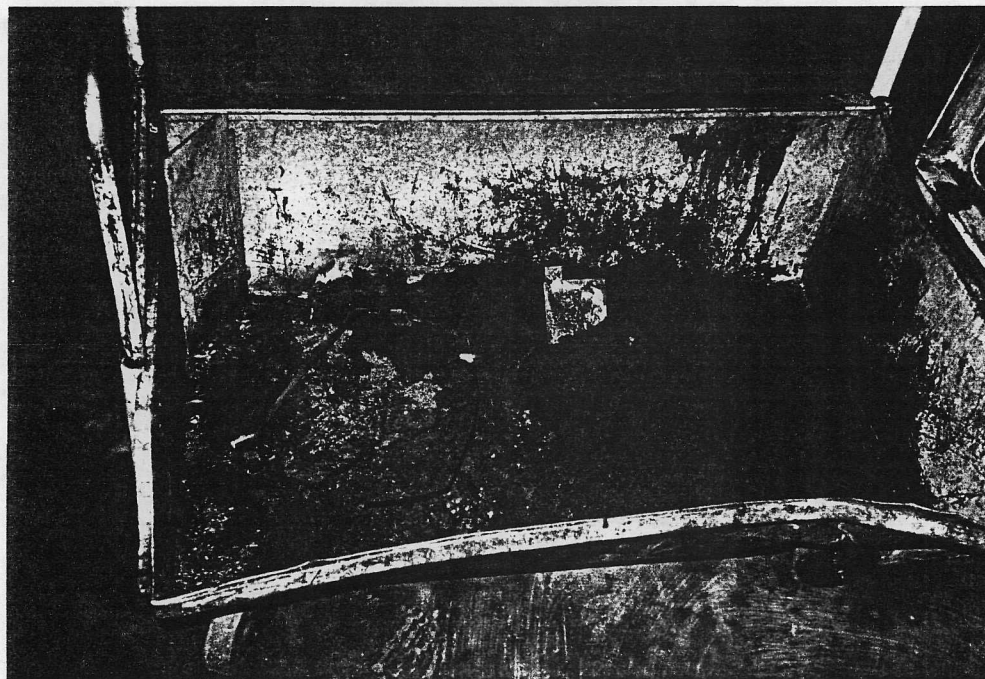
Photograph No. 7

Location: SWMU 2

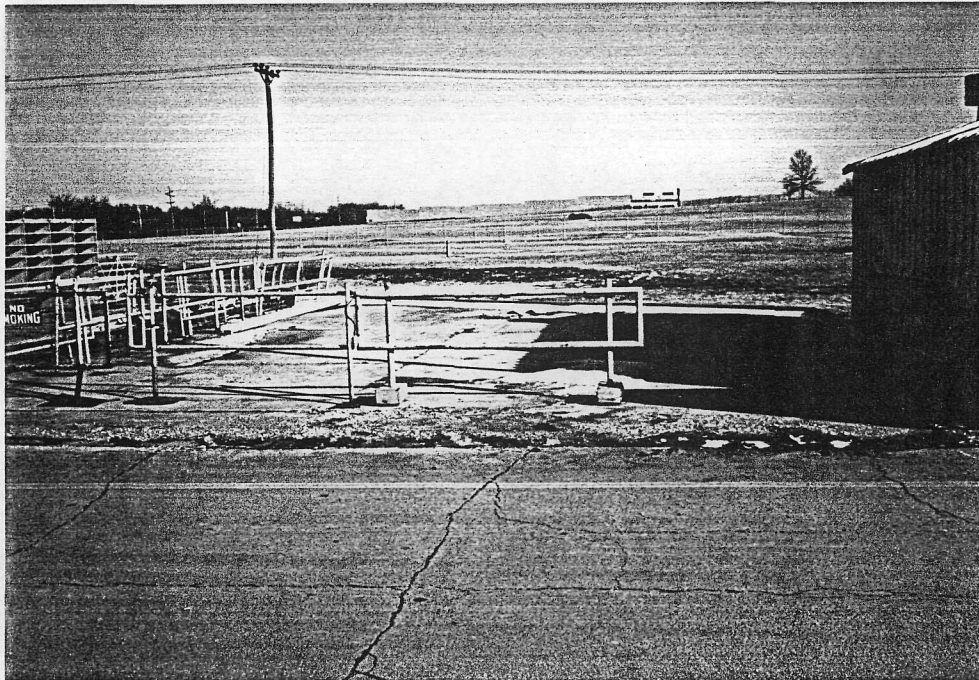
Observations: The unit was empty during the VSI. There were cracks in the concrete pad. No evidence of release was noted.

Photograph No. 8
 Orientation: East
 Description: Former Hazardous Waste Storage Area No. 1

Location: SWMU 5
 Date: 01/24/92

Recommendations: RAI recommends remediation of the cadmium-contaminated area.

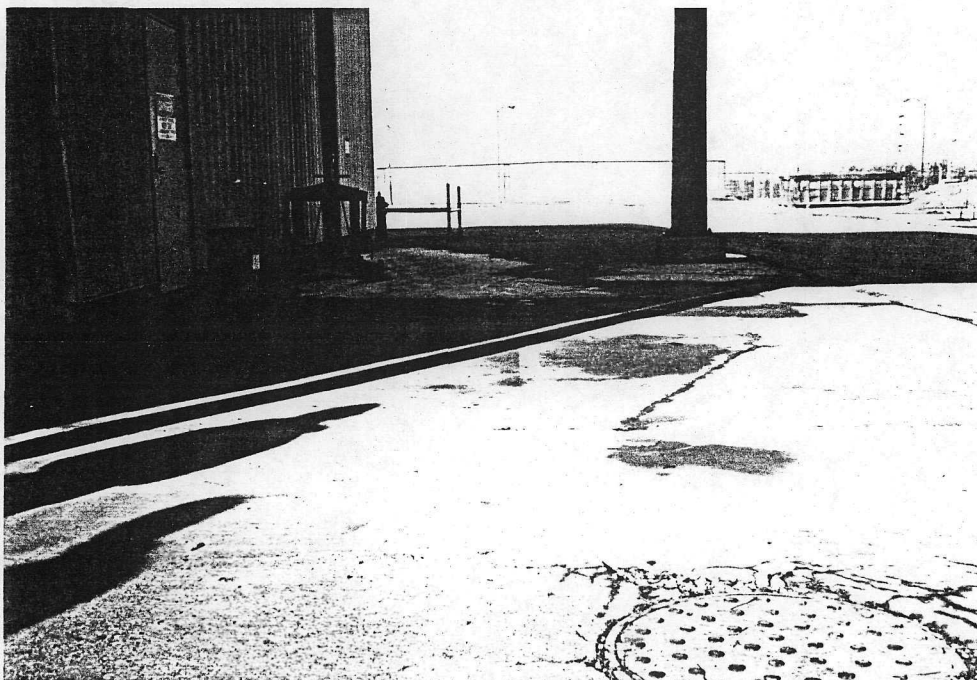
Ten soil samples were collected from five locations in the area of SWMU 6. TCE was detected in samples taken around the southern half of the pad. Harza determined this was caused from the 1991 TCE spill.

Unit Description: The Former Hazardous Waste Storage Area No. 2 is a concrete area located outdoors, adjacent to the east side of the facility. The unit is approximately 40 feet by 12 feet with a canopy covering 60 percent of the unit (see Photograph No. 9).

Observations: The unit was empty during the VSI. One crack in the concrete was visible. No visible evidence of release was noted.

Photograph No. 9
 Orientation: North
 Description: Former Hazardous Waste Storage Area No. 2

Location: SWMU 6
 Date: 01/24/92

Recommendations: RAI recommends the remediation of the TCE-contaminated soil.

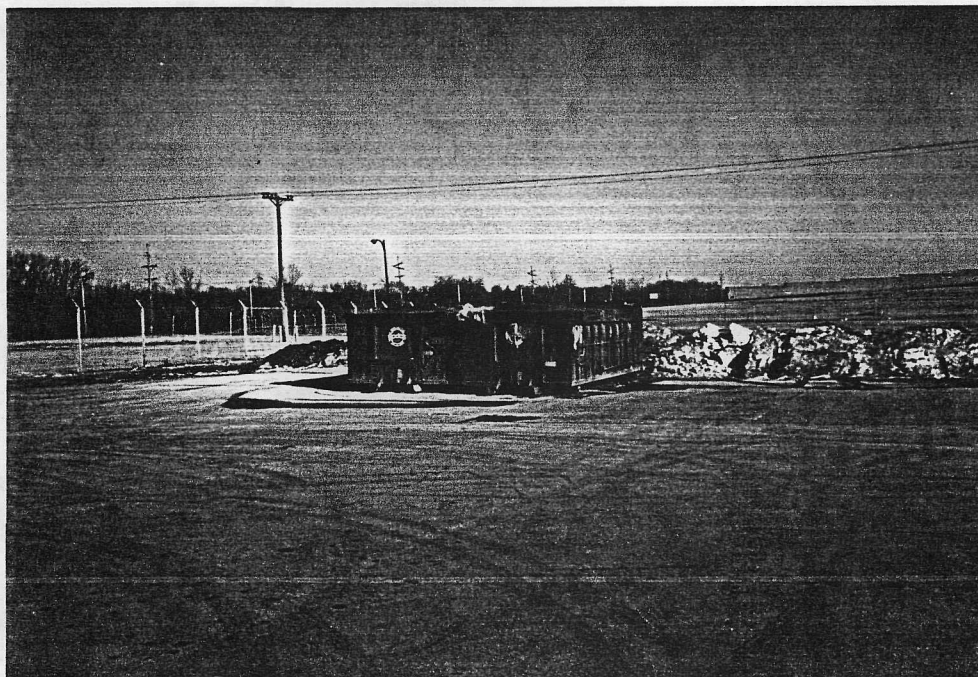
Photograph No. 10

Unit Description: The Hazardous Waste Storage Area No. 2 is located outdoors, northeast of the facility. The unit stores hazardous waste in one 20-cubic-yard roll-off box and concrete in two steel dumpsters. The unit measures 40 feet by 55 feet and has an 8-inch concrete pad (see Photograph No. 10). No drains are located in the area.

The unit contained two steel dumpsters of excavated concrete waiting for disposal. No cracks were visible in the concrete pad.

Description: This is the Hazardous Waste Storage Area No. 2. The two steel dumpsters contain concrete that was removed from the Trichloroethene Spill Area.

Recommendations: RAI recommends no further action at this time.

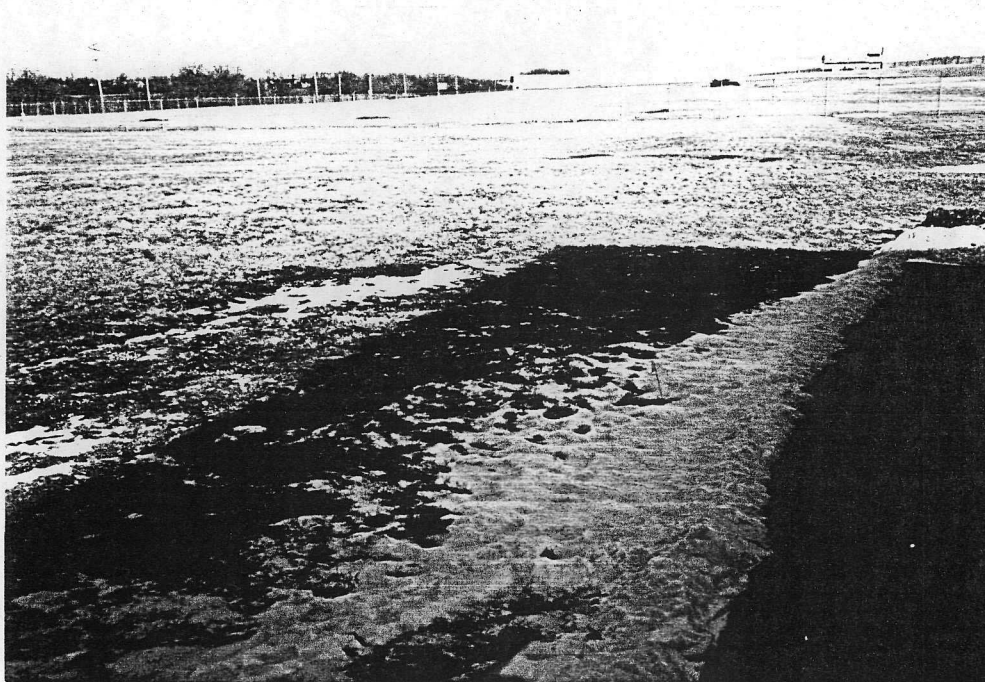
Photograph No. 12

Unit Description: This unit was a solid waste incinerator located outdoors on the east side of the site. This unit measured approximately 20 feet by 20 feet (see Photograph No. 12).
